West Virginia Chemical Leak
Etowah, Kanawha County, West Virginia
TDD No TL01-14-01-001

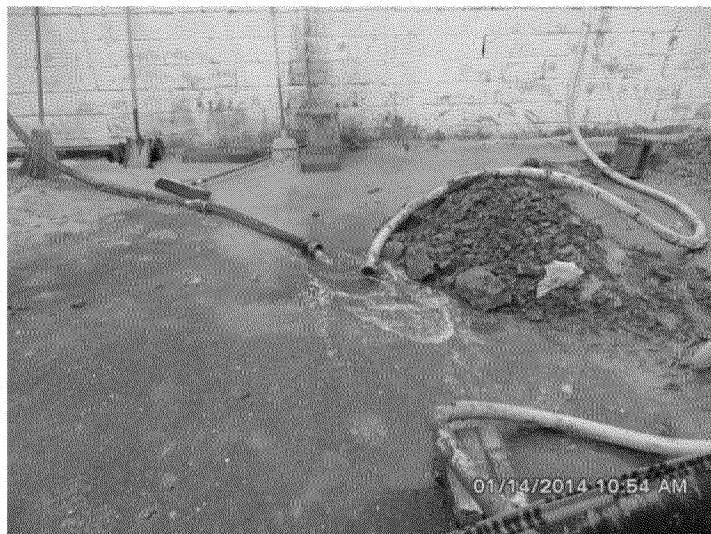
Photo No. SAM_1658; Taken on 01/14/14 at 10:54 hours by START MG. Pipe discharge been pumped from the sump under the pipe back into the containment area

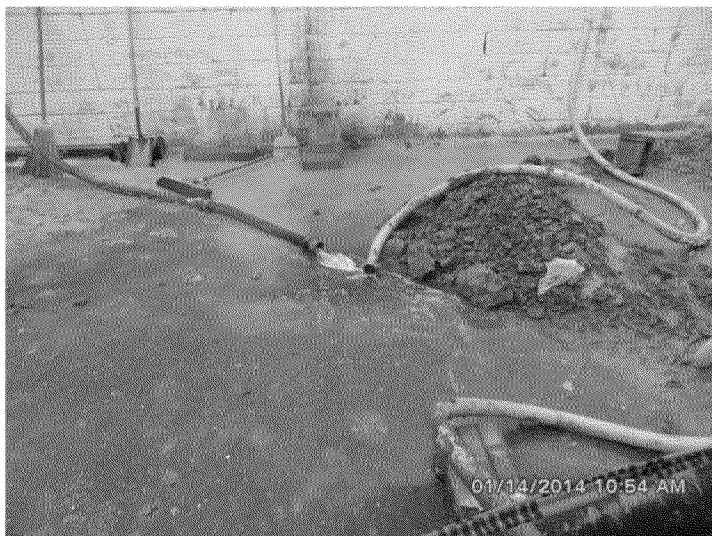
Photo No. SAM_1659; Taken on 01/14/14 at 10:59 hours by START MG. Pipe discharge been pumped from the sump under the pipe back into the containment area

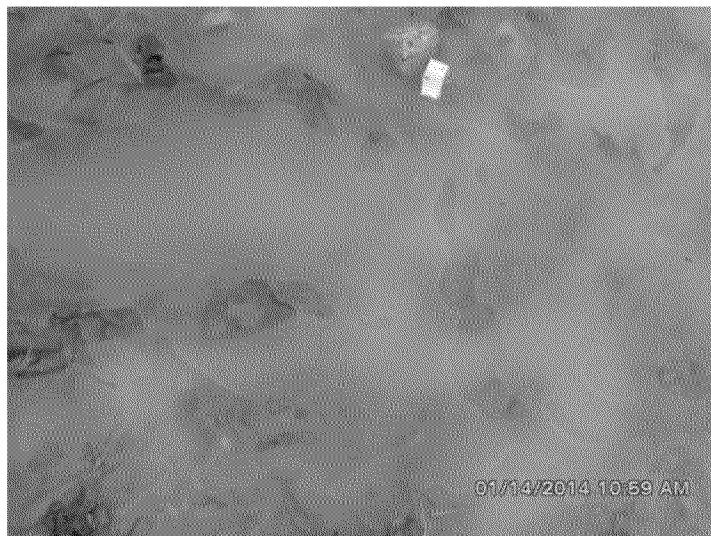
Photo No. SAM_1660; Taken on 01/14/14 at 11:02 hours by START MG. Sheen on storm water under walkway into containment area

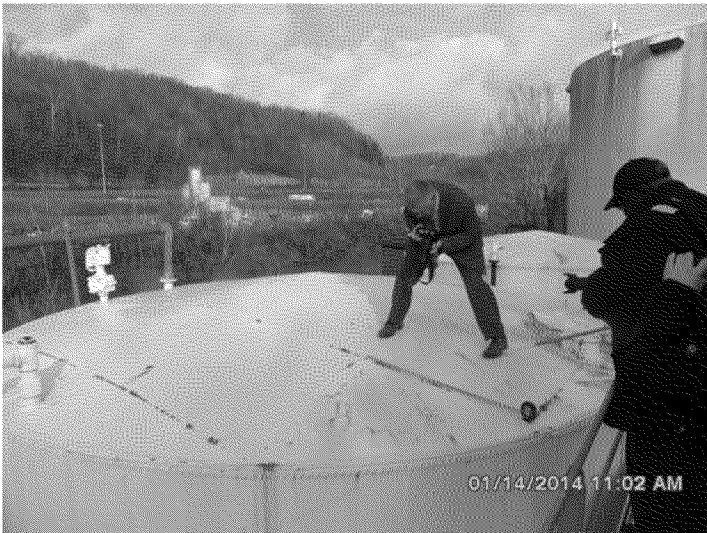
Photo No. SAM_1663; Taken on 01/14/14 at 11:03 hours by START MG. Attorney General Investigator photographing a seam on top of the breached tank

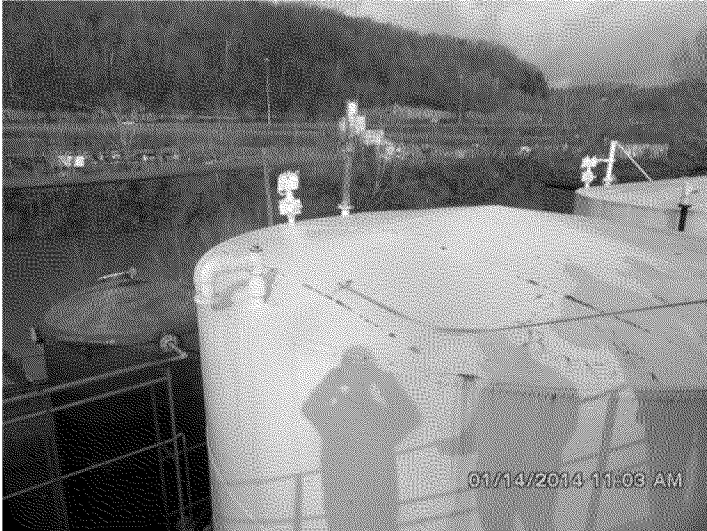
Photo No. SAM_1665; Taken on 01/14/14 at 11:04 hours by START MG. CSB investigator point out rust spot on top of tank

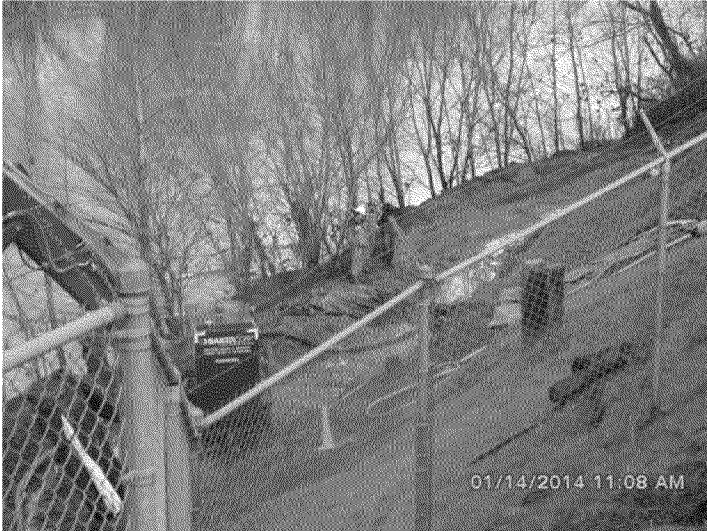
Photo No. SAM_1669; Taken on 01/14/14 at 11:08 hours by START MG. RP Contractors draining and rolling up the old liner in the containment pond

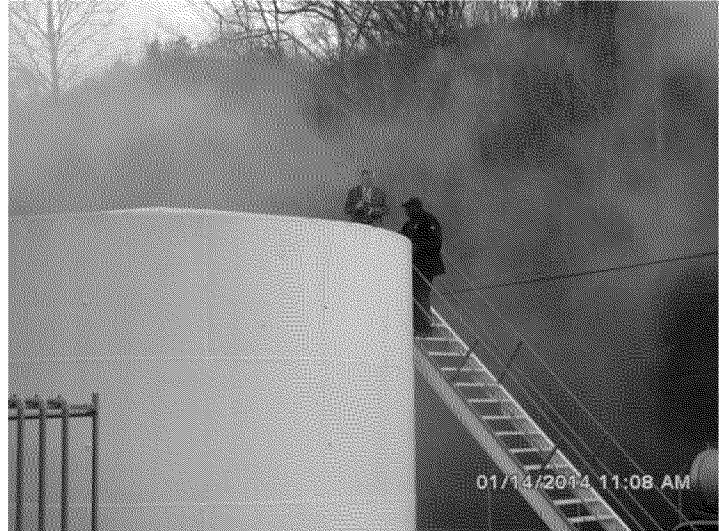
Photo No. SAM_1670; Taken on 01/14/14 at 11:09 hours by START MG. Attorney General and CSB Investigators looking at top of tank next to breached tank

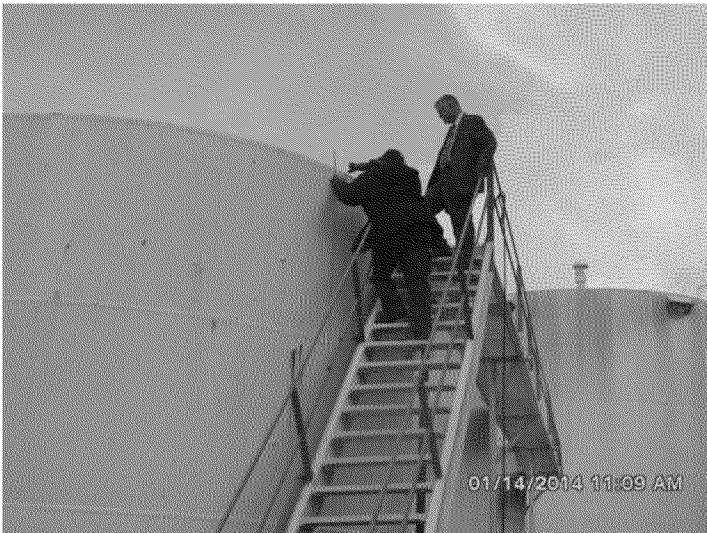
Photo No. SAM_1671; Taken on 01/14/14 at 12:46 hours by START MG. Attorney General and CSB Investigators looking at top of tank next to breached tank

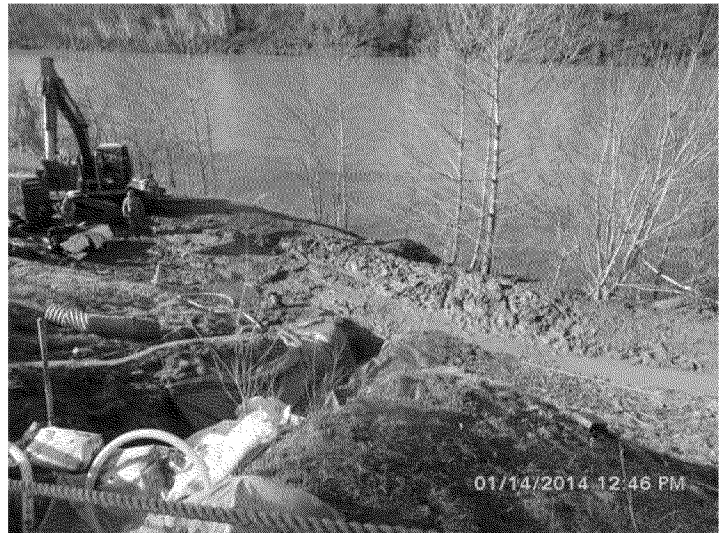
Photo No. SAM_1672; Taken on 01/14/14 at 12:57 hours by START MG. Old Liner material in collection pond fully removed

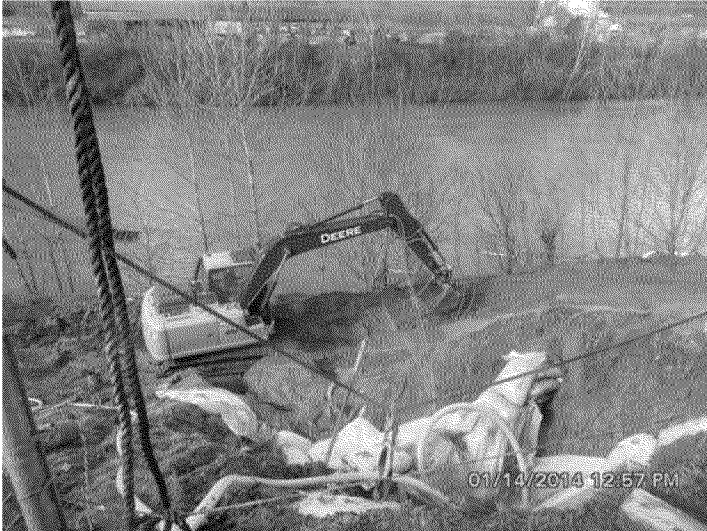
Photo No. SAM_1673; Taken on 01/14/14 at 13:04 hours by START MG. Track hoe moving into make improvements to start the collection trench and pond

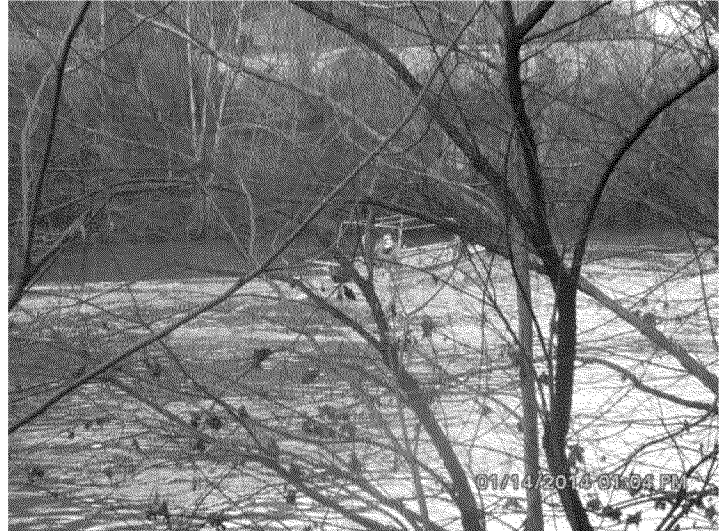
Photo No. SAM_1674; Taken on 01/14/14 at 13:15 hours by START MG. View of river boom location modifications based on USCG review

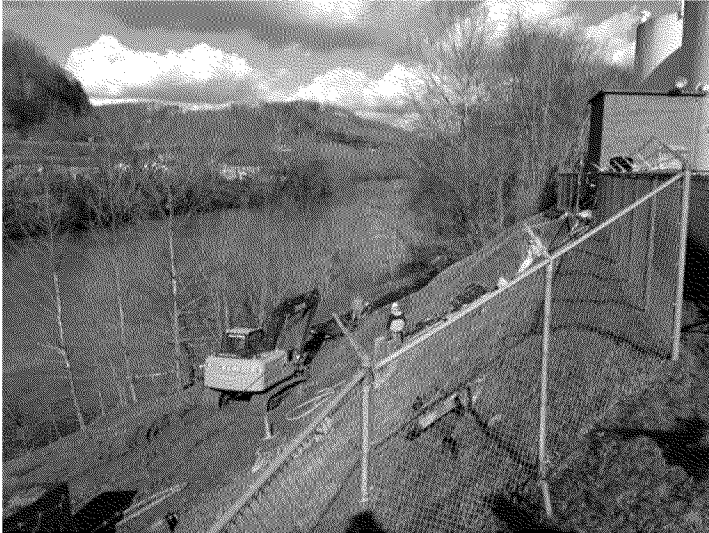
Photo No. IMG_2139; Taken on 01/14/14 at 13:35 hours by START MG. Improvements being made to the collection trench

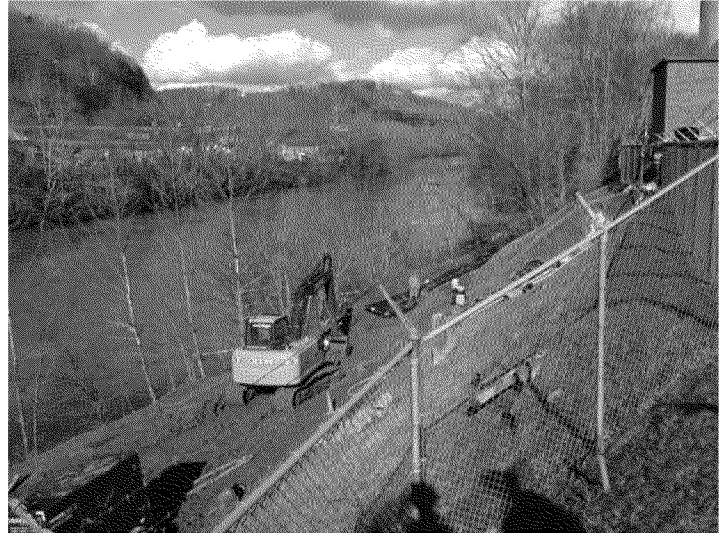
Photo No. IMG_2140; Taken on 01/14/14 at 13:44 hours by START MG. Perspective view - collection trench upgrades being implemented

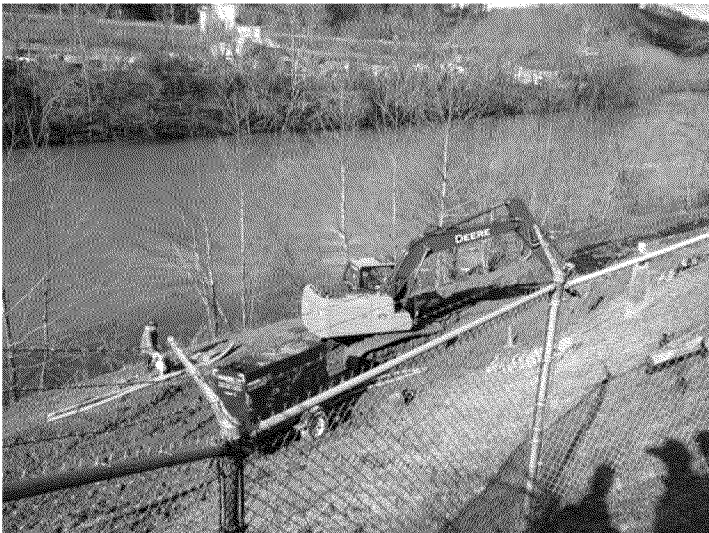
Photo No. IMG_2141; Taken on 01/14/14 at 13:50 hours by START MG. View of collection trench improvements being implemented

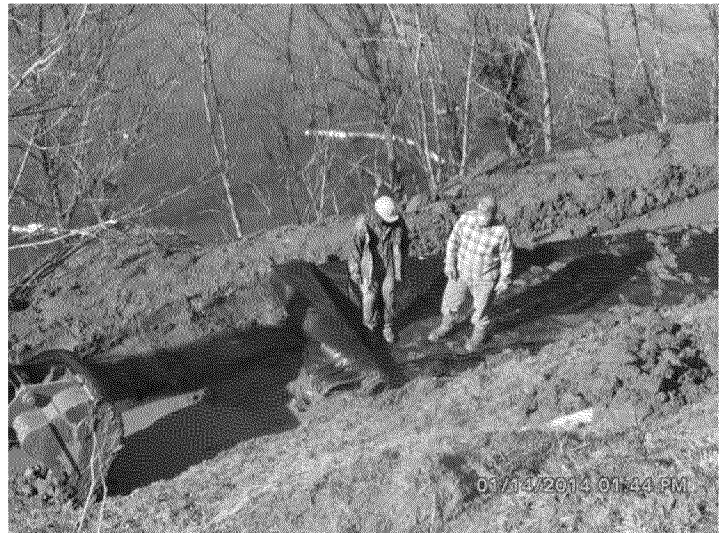
Photo No. SAM_1676; Taken on 01/14/14 at 13:45 hours by START MG. New liner material being unrolled on collection trench/pond area

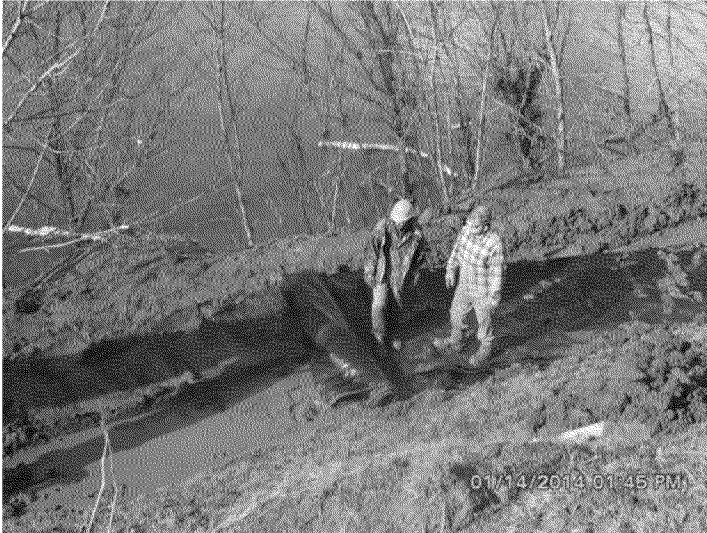
Photo No. SAM_1677; Taken on 01/14/14 at 13:48 hours by START MG. New liner material being unrolled on collection trench/pond area

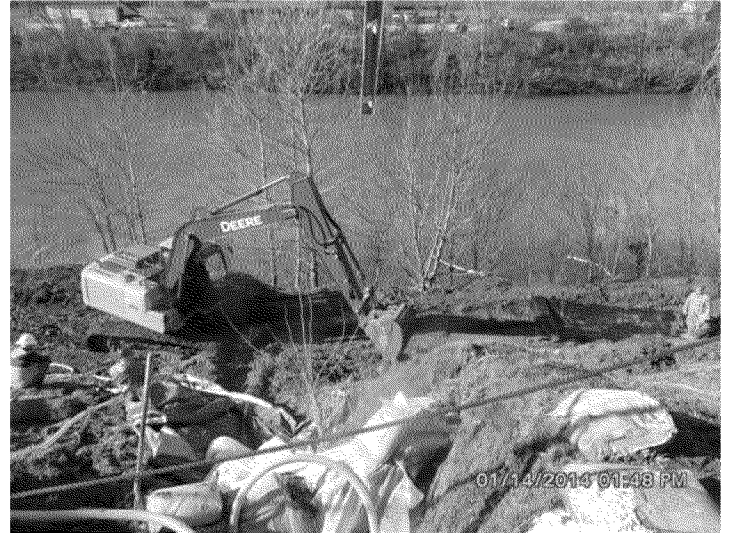
Photo No. SAM_1678; Taken on 01/14/14 at 13:52 hours by START MG. Collection pond area being enlarged

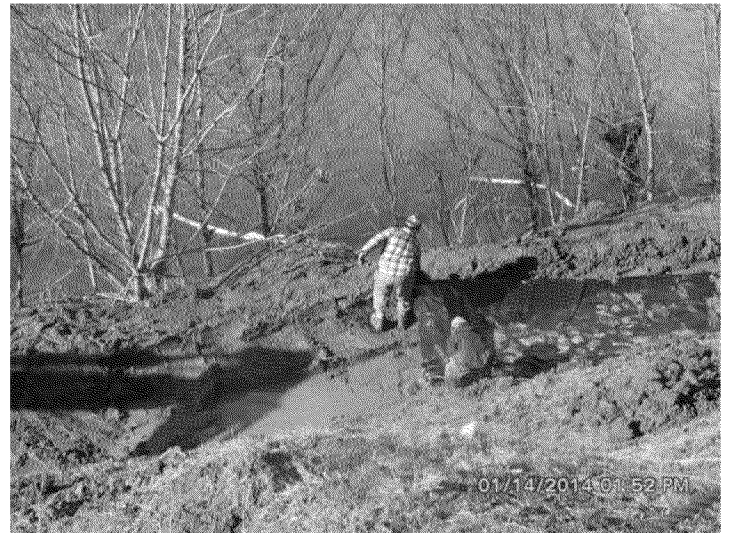
Photo No. SAM_1679; Taken on 01/14/14 at 13:52 hours by START MG . RP contractors unrolling liner

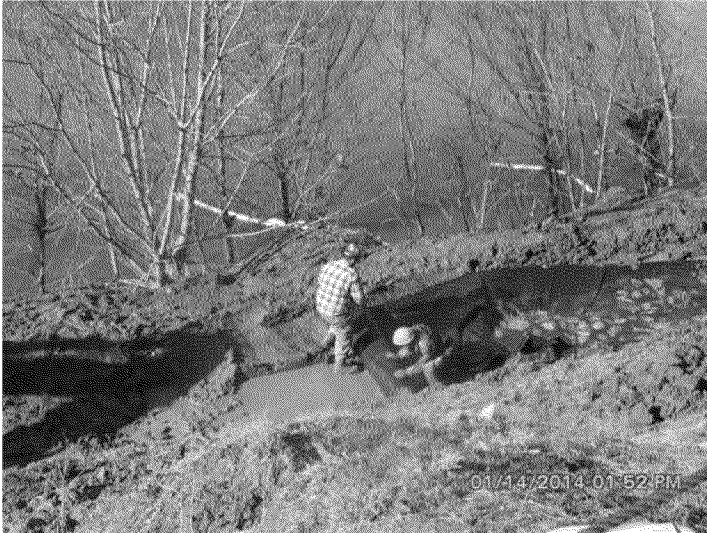
Photo No. SAM_1680; Taken on 01/14/14 at 13:54 hours by
START MG. RP contractors unrolling liner

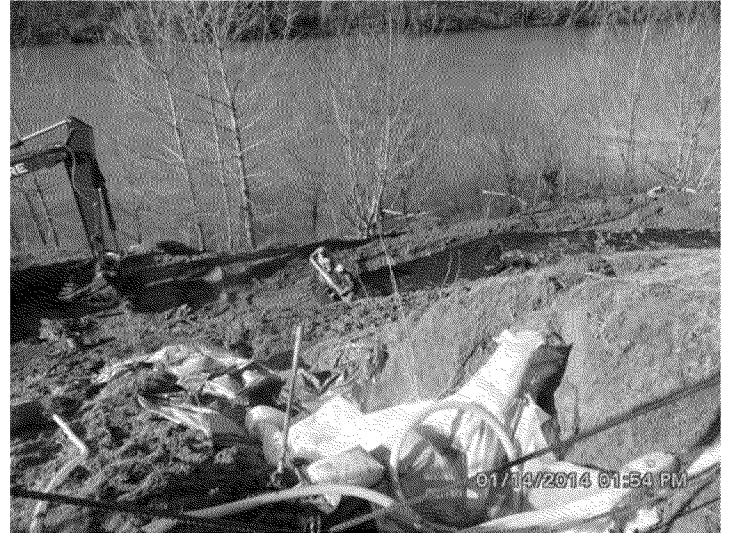
Photo No. SAM_1681; Taken on 01/14/14 at 14:05 hours by
START MG. RP contractors unrolling liner

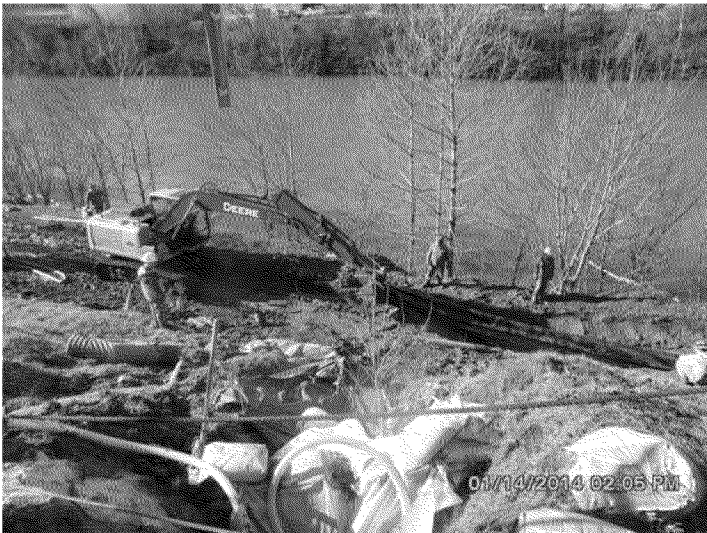
Photo No. SAM_1682; Taken on 01/14/14 at 14:09 hours by
START MG. Liner material being drug into place

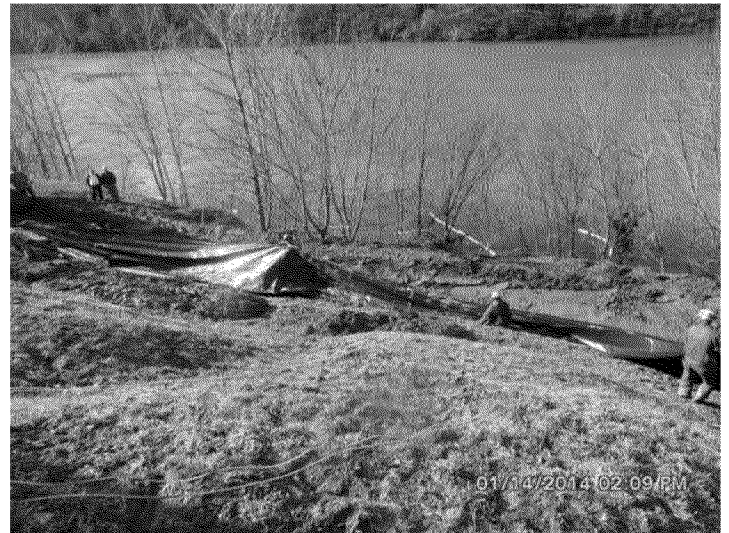
Photo No. SAM_1683; Taken on 01/14/14 at 14:09 hours by
START MG. RP contractors unfolding liner in trench

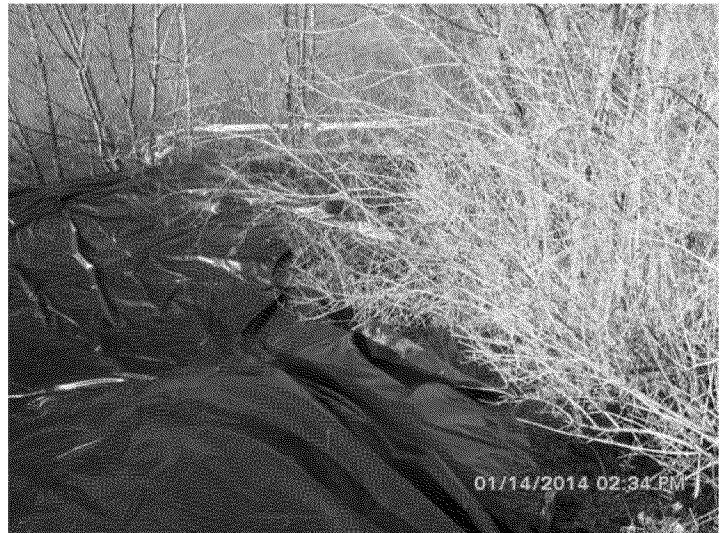
Photo No. SAM_1691; Taken on 01/14/14 at 14:34 hours by START MG. Extent north (upstream) of trench liner upgrade installation

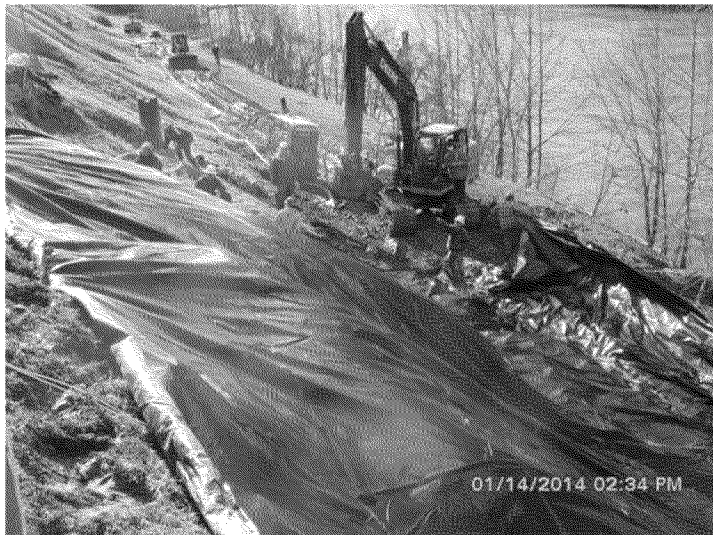
Photo No. SAM_1692; Taken on 01/14/14 at 14:44 hours by START MG. View of collection trench liner being spread across grade of hillside

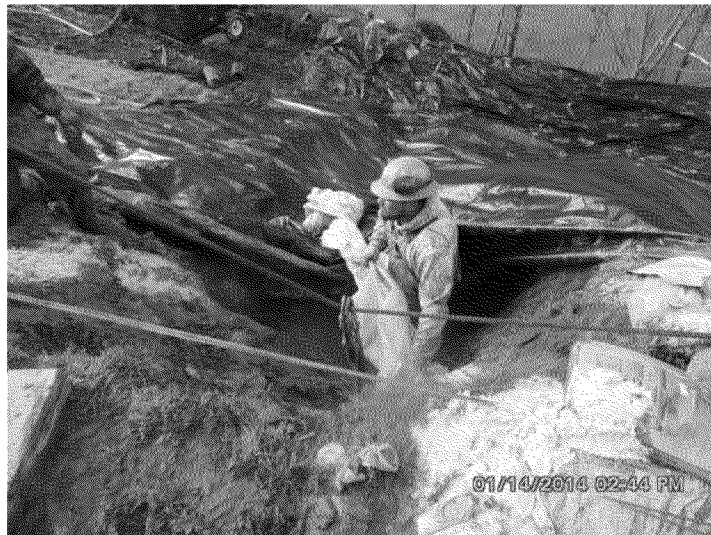
Photo No. SAM_1693; Taken on 01/14/14 at 14:45 hours by START MG. RP contractor diverting water discharge from the pipe onto the liner

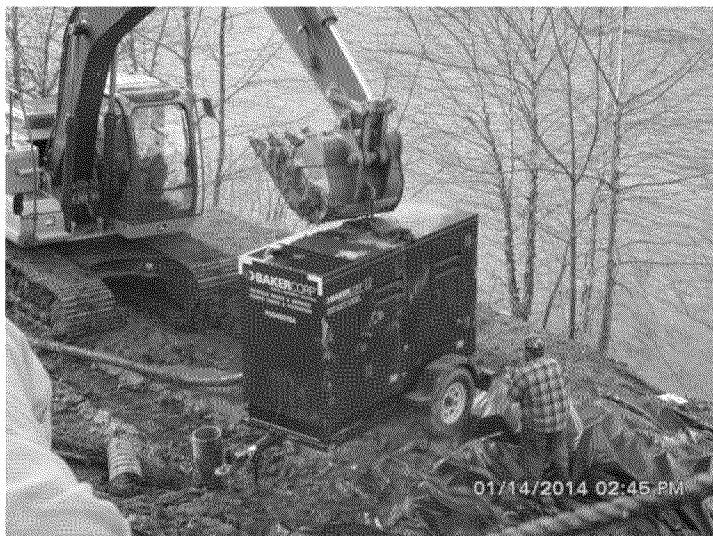
Photo No. SAM_1694; Taken on 01/14/14 at 15:59 hours by START MG. Pump being moved into place to remove water from liner

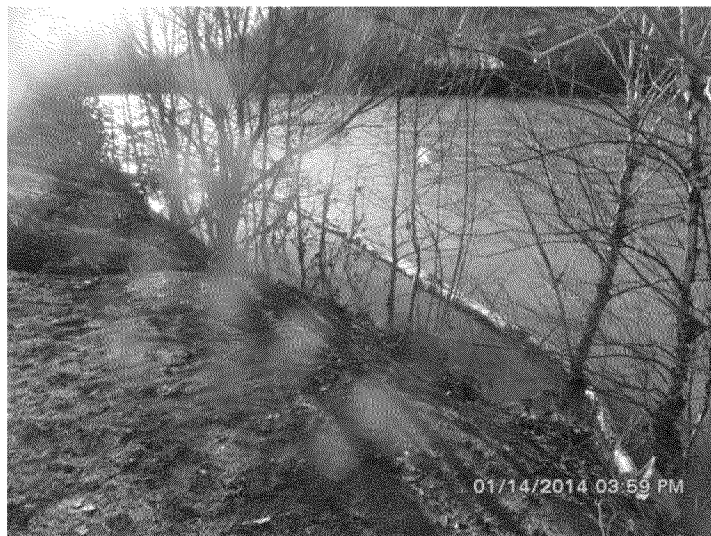
Photo No. SAM_1695; Taken on 01/14/14 at 16:04 hours by START MG. Booms in place along river bank

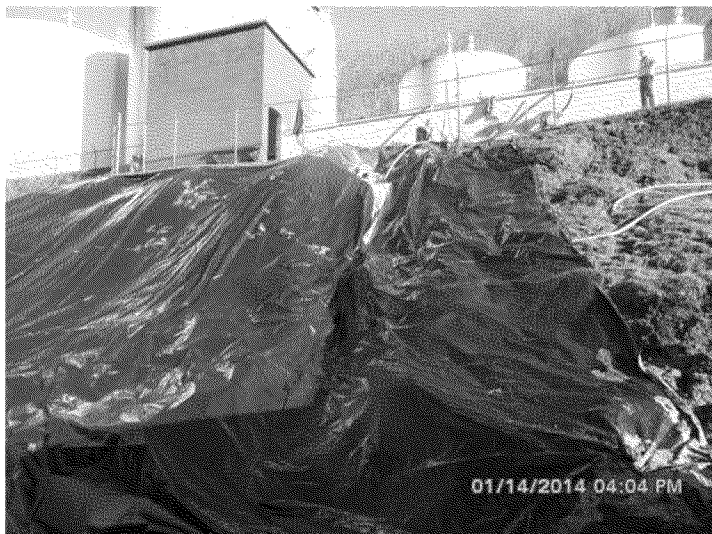
Photo No. SAM_1696; Taken on 01/14/14 at 16:04 hours by START MG. Look up hill at pipe discharge

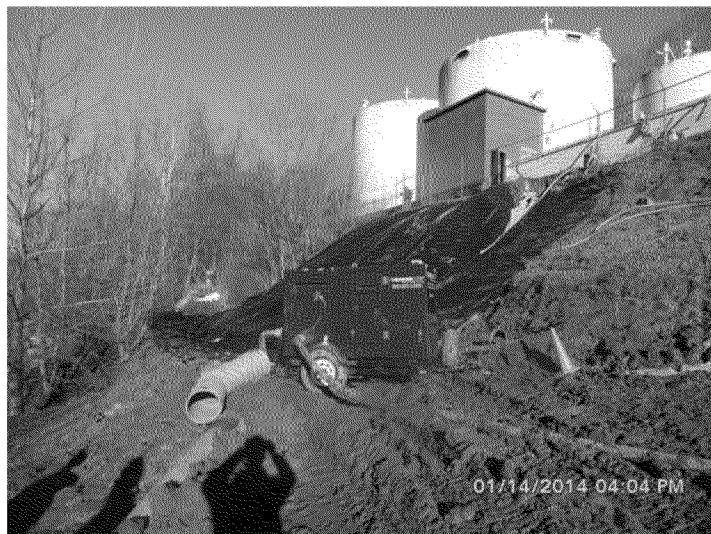
Photo No. SAM_1697; Taken on 01/14/14 at 16:05 hours by START MG. Collection trench/containment pond improvements complete

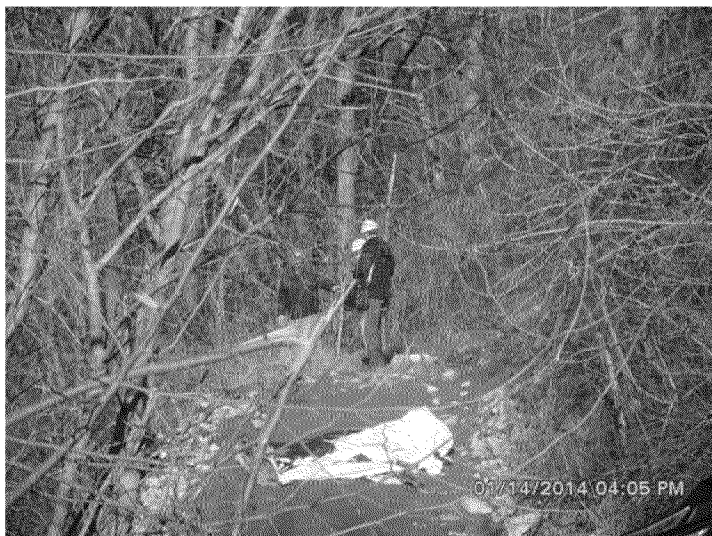
Photo No. SAM_1698; Taken on 01/14/14 at 16:06 hours by START MG. discharge being examined above the collection trench

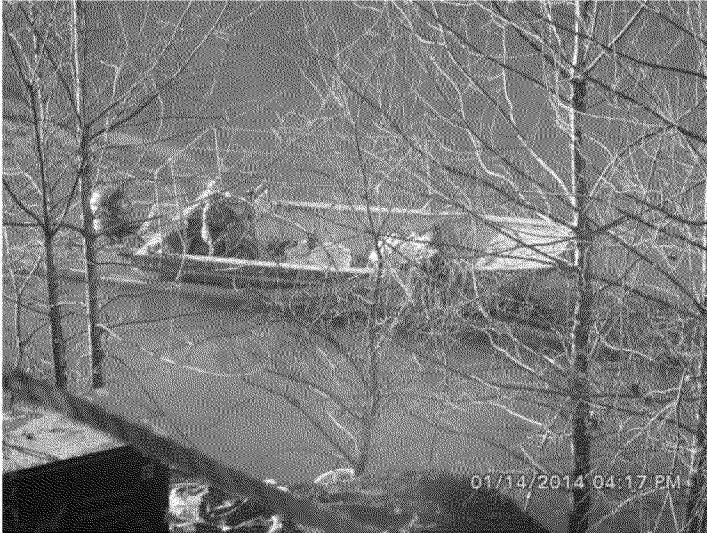
Photo No. SAM_1700; Taken on 01/14/14 at 16:18 hours by
START MG. RP contractor adjusting hard booms along bank

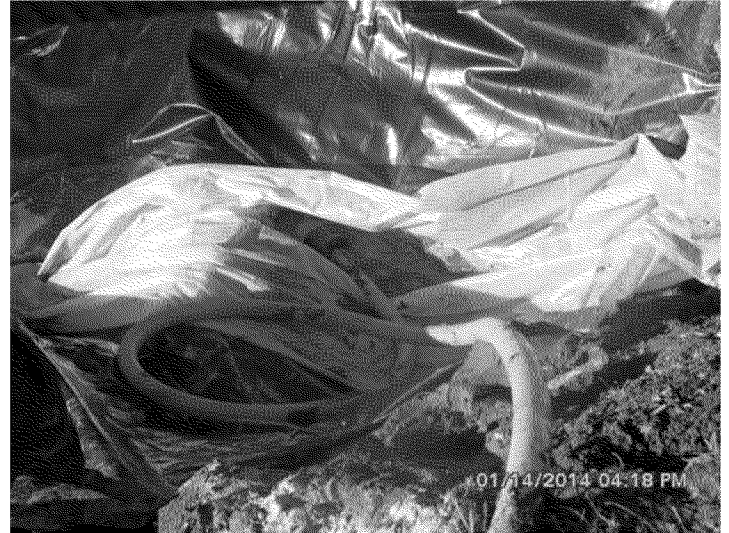
Photo No. SAM_1701; Taken on 01/14/14 at 16:21 hours by
START MG. Improved sump setup under pipe discharge

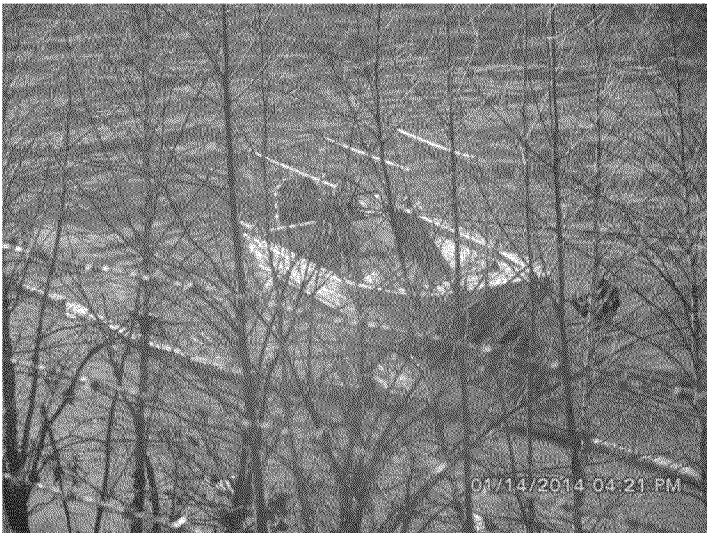
Photo No. SAM_1702; Taken on 01/14/14 at 16:41 hours by
START MG. RP contractors adjusting booms

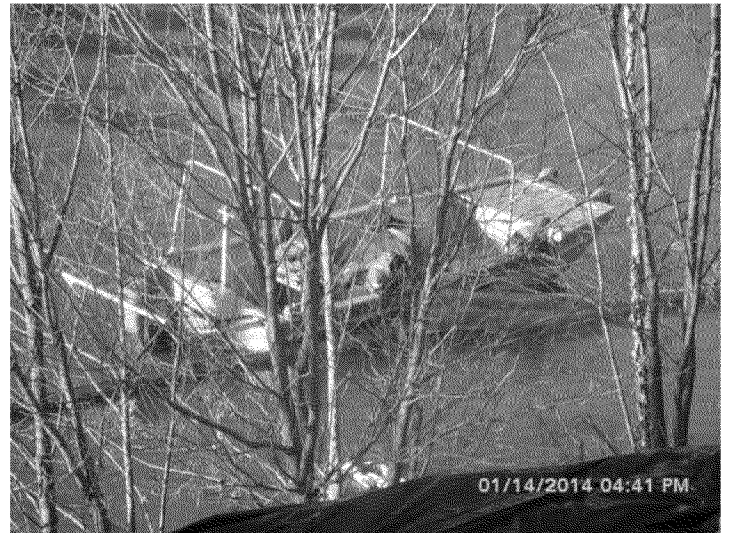
Photo No. SAM_1703; Taken on 01/14/14 at 16:42 hours by
START MG. RP contractors adjusting booms

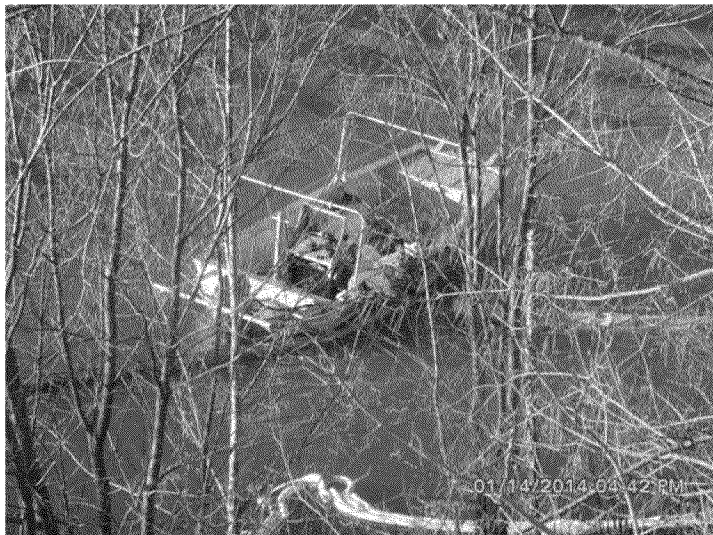
Photo No. SAM_1704; Taken on 01/14/14 at 17:39 hours by START MG. RP contractors adjusting booms

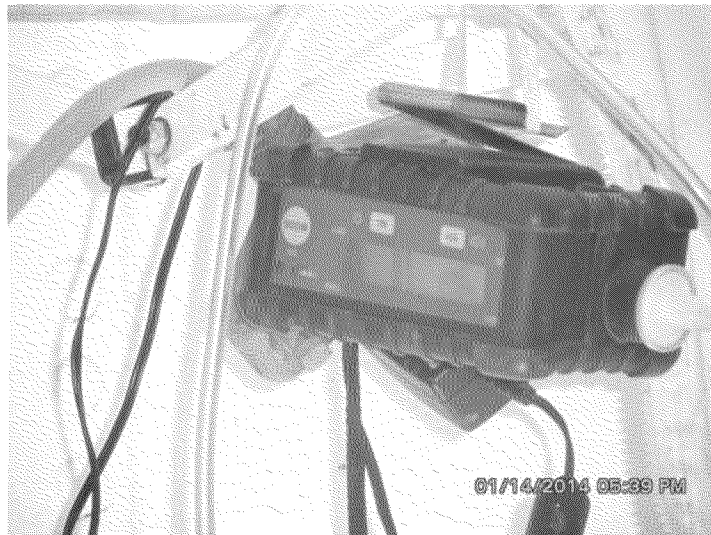
Photo No. SAM_1705; Taken on 01/14/14 at 17:39 hours by START MG. RP contractor air monitoring in place for confined space entry into tank

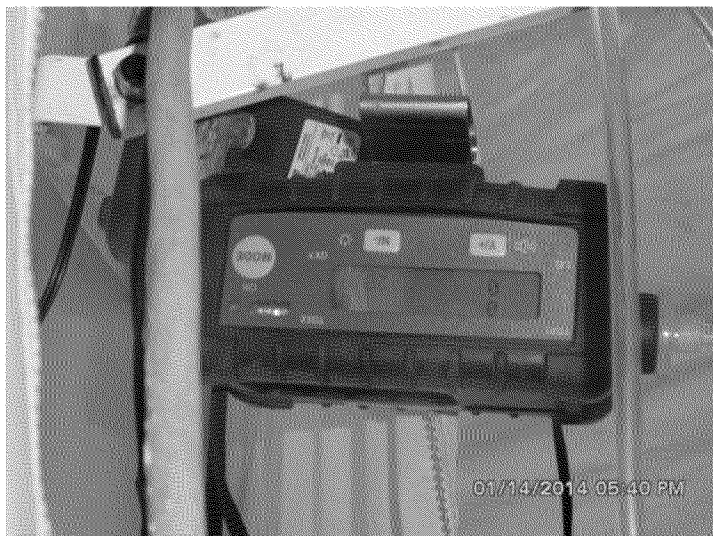
Photo No. SAM_1708; Taken on 01/14/14 at 17:41 hours by START MG. Air monitor used for confined space entry

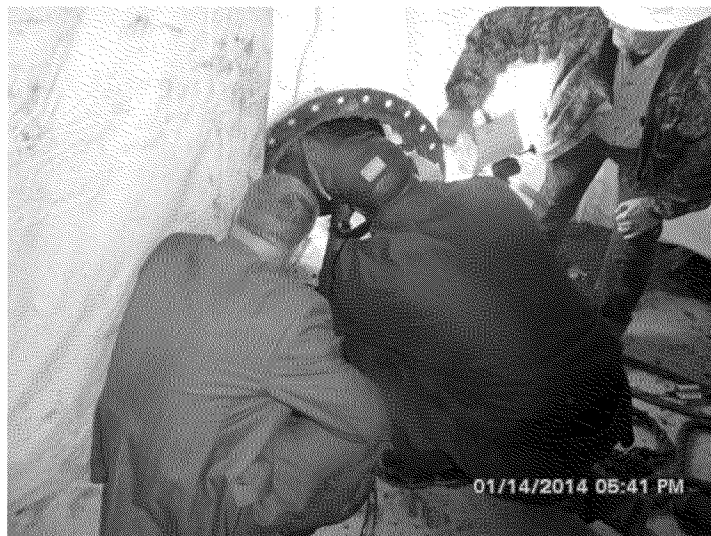
Photo No. SAM_1709; Taken on 01/14/14 at 17:45 hours by START MG. CSB and Attorney General Investigators photographing the RP contractor taking photos inside of the tank

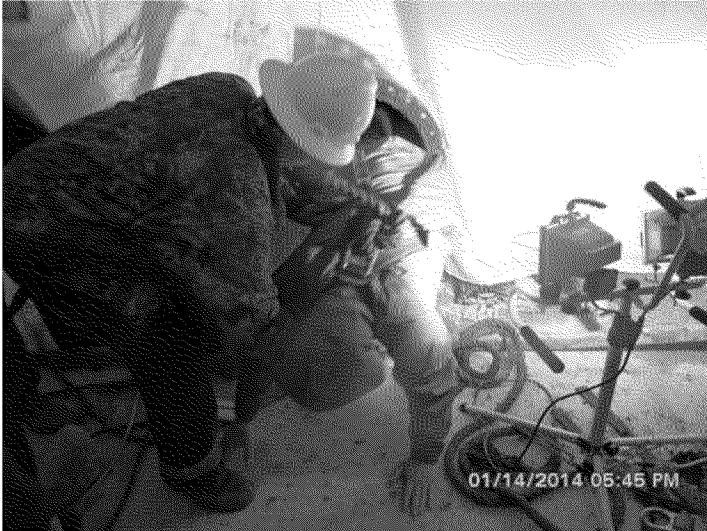
Photo No. SAM_1710; Taken on 01/14/14 at 17:47 hours by
START MG. RP contractor exiting the tank after taking pictures

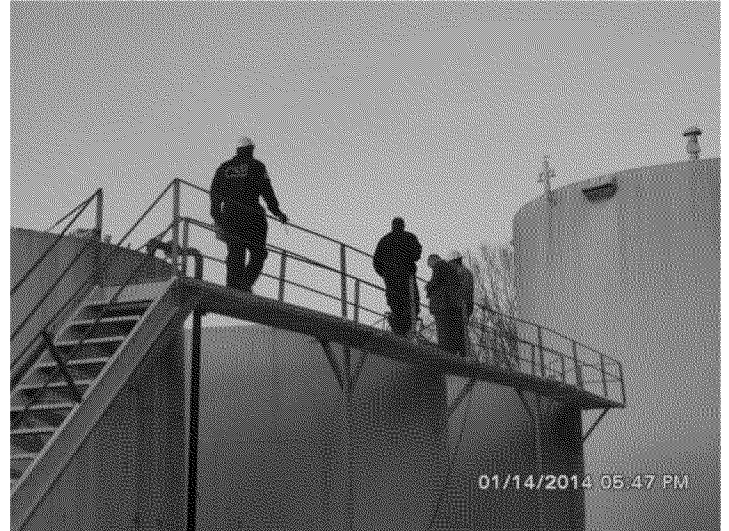
Photo No. SAM_1711; Taken on 01/14/14 at 17:48 hours by
START MG. RP contractor and CSB/Attorney General
Investigators looking at the top of the tank

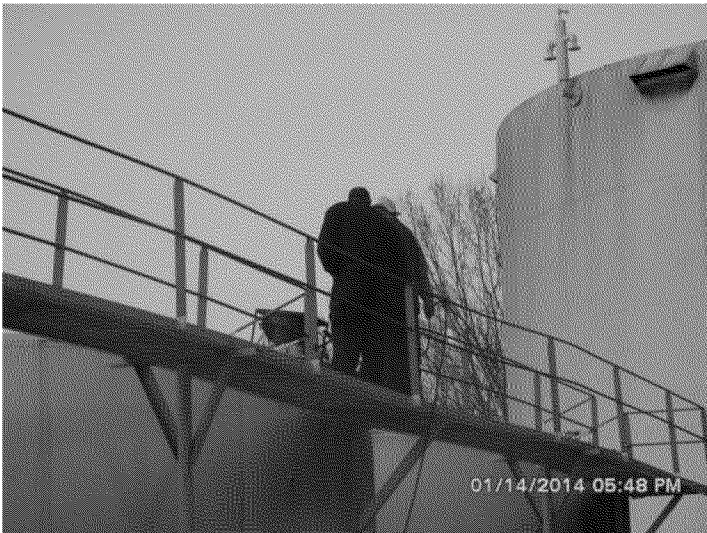
Photo No. SAM_1712; Taken on 01/14/14 at 9:04 hours by
START MG. CSB and RP contractor discussing venting on top
of the tank

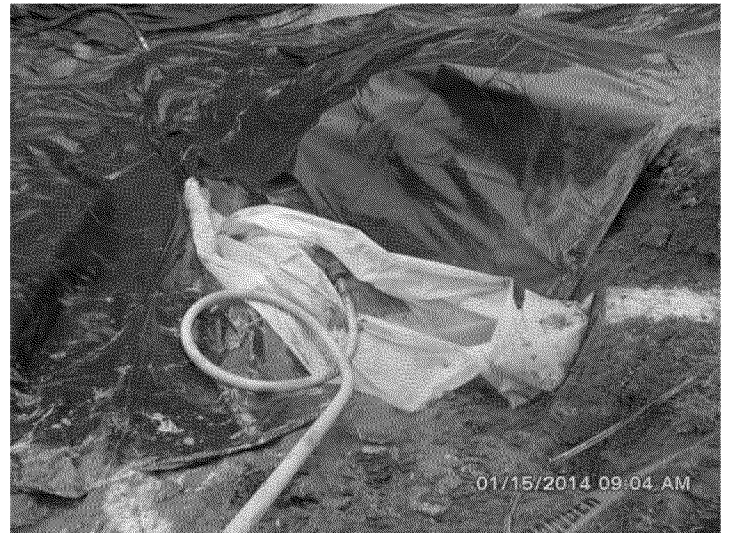
Photo No. SAM_1713; Taken on 01/15/14 at 9:10 hours by
START MG. Sump still moving discharge back into containment
area

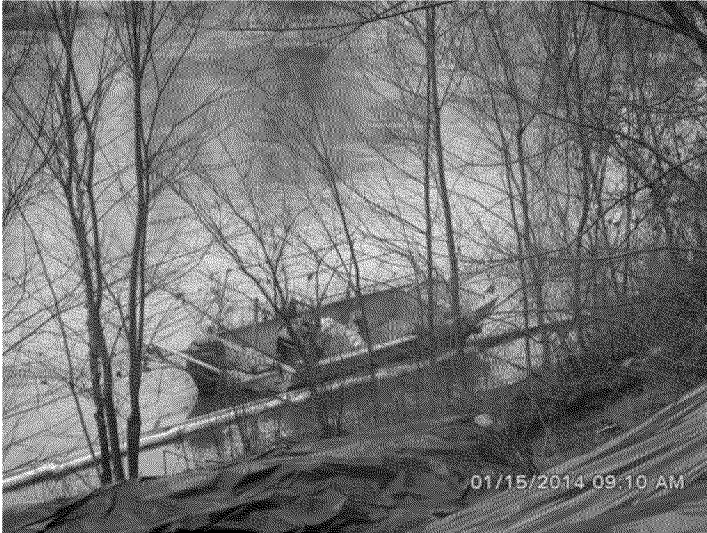
Photo No. SAM_1714; Taken on 01/15/14 at 9:24 hours by
START MG. RP Contractors changing out absorbent booms

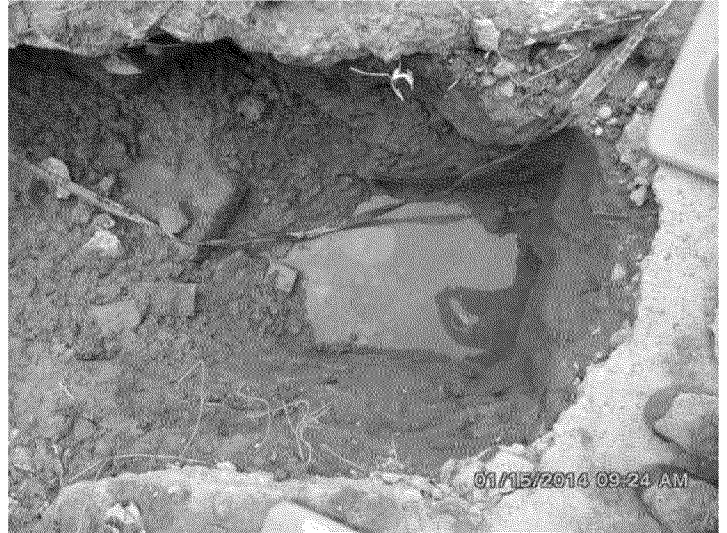
Photo No. SAM_1715; Taken on 01/15/14 at 9:26 hours by
START MG. Product surfacing in exploratory pit

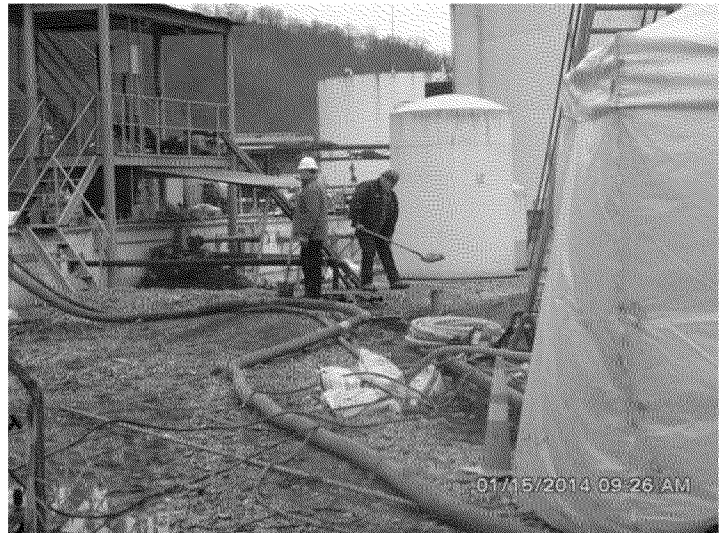
Photo No. SAM_1717; Taken on 01/15/14 at 10:30 hours by
START MG. gravel being spread around walk way

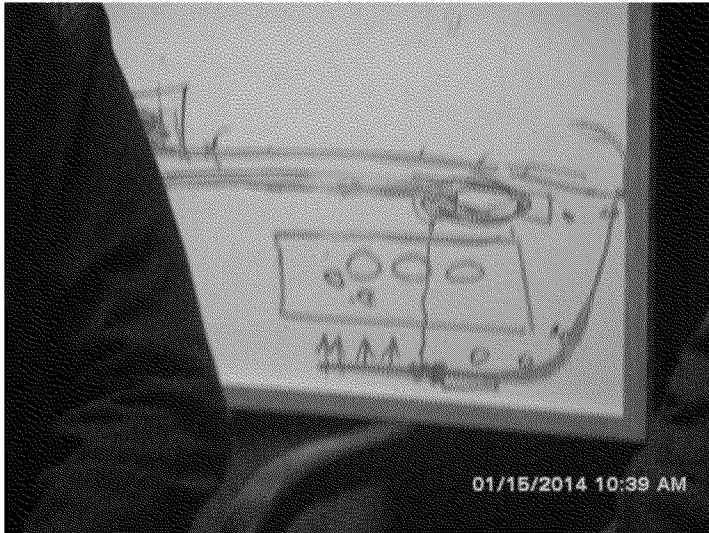
Photo No. SAM_1726; Taken on 01/15/14 at 10:39 hours by
START MG. Drawing of water entering site

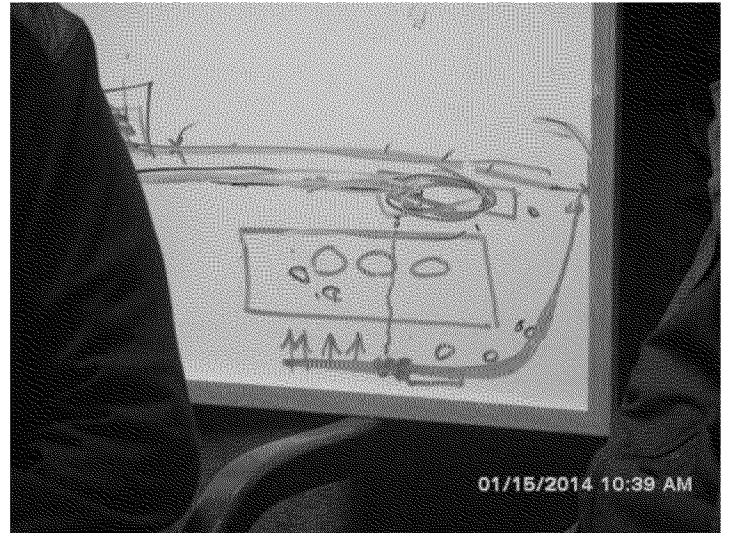
Photo No. SAM_1727; Taken on 01/15/14 at 10:41 hours by
START MG. Drawing of water entering site

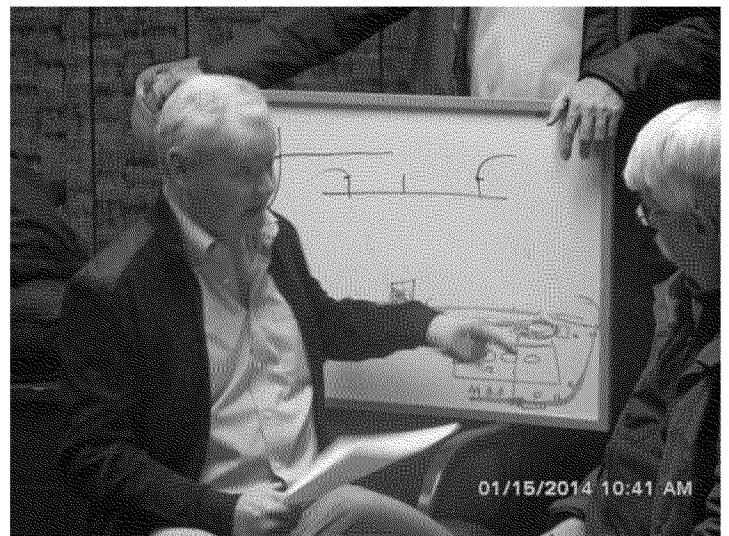
Photo No. SAM_1729; Taken on 01/15/14 at 11:01 hours by
START MG. Discussion of collection pond

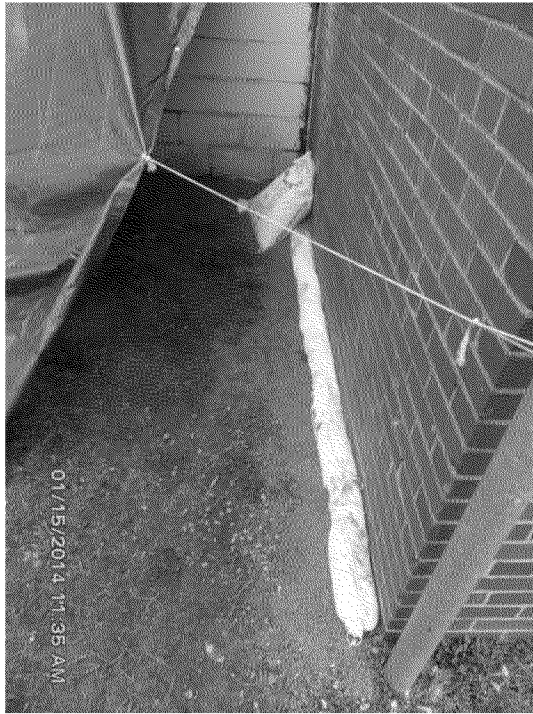
Photo No. SAM_1734; Taken on 01/15/14 at 11:35 hours by START MG. Absorbent boom along side brick building

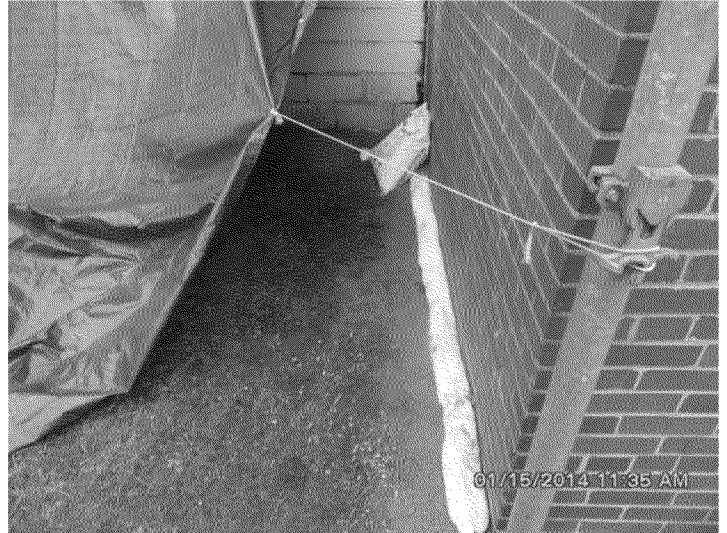
Photo No. SAM_1735; Taken on 01/15/14 at 11:35 hours by START MG. Absorbent boom along side brick building

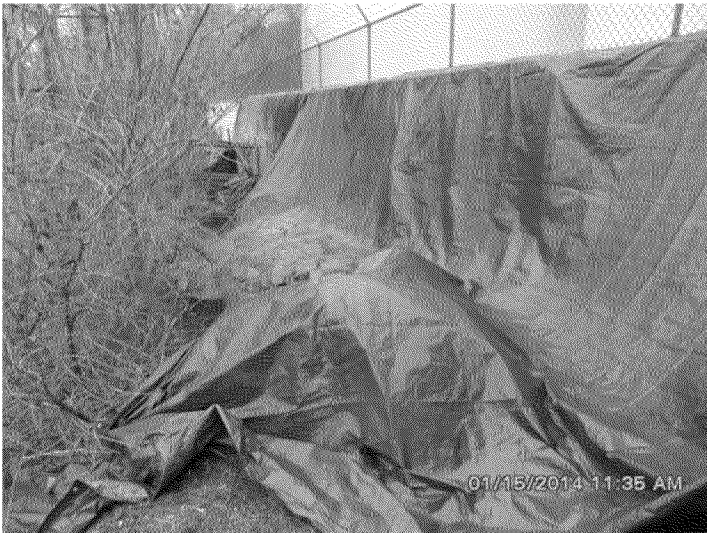
Photo No. SAM_1736; Taken on 01/15/14 at 11:39 hours by START MG. Tarps diverting rain water from contaminated soil outside of the containment area

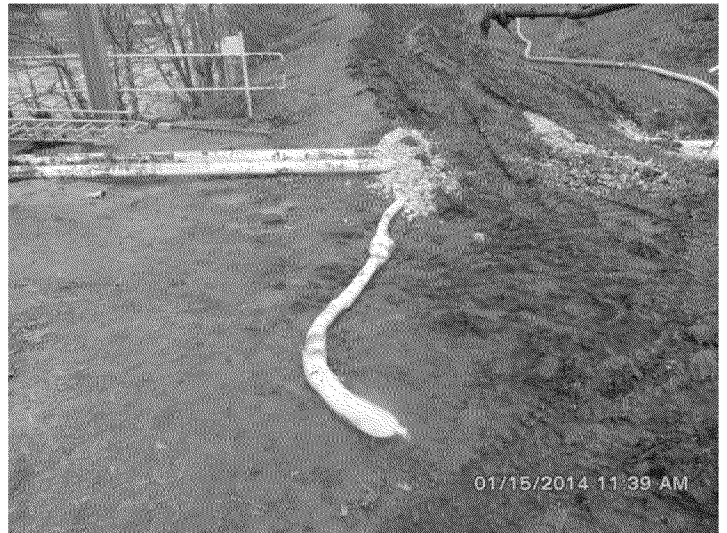
Photo No. SAM_1737; Taken on 01/15/14 at 11:39 hours by START MG. Absorbent boom placed in front of dock

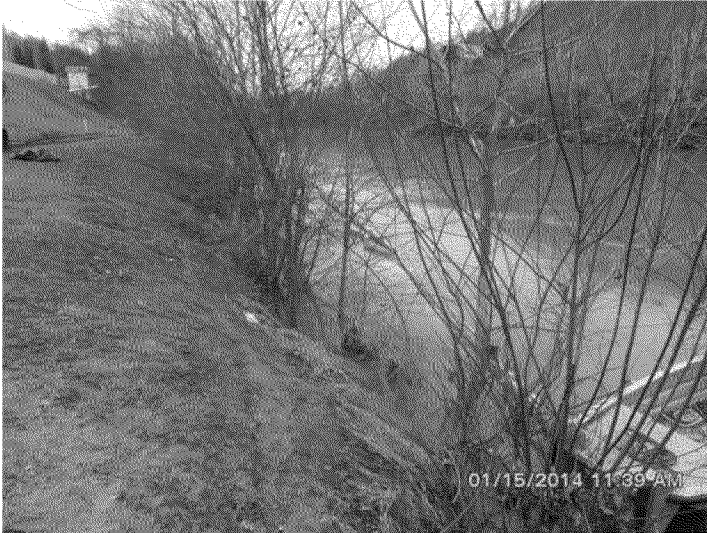
Photo No. SAM_1738; Taken on 01/15/14 at 11:41 hours by START MG . Booming locations south of the boat dock

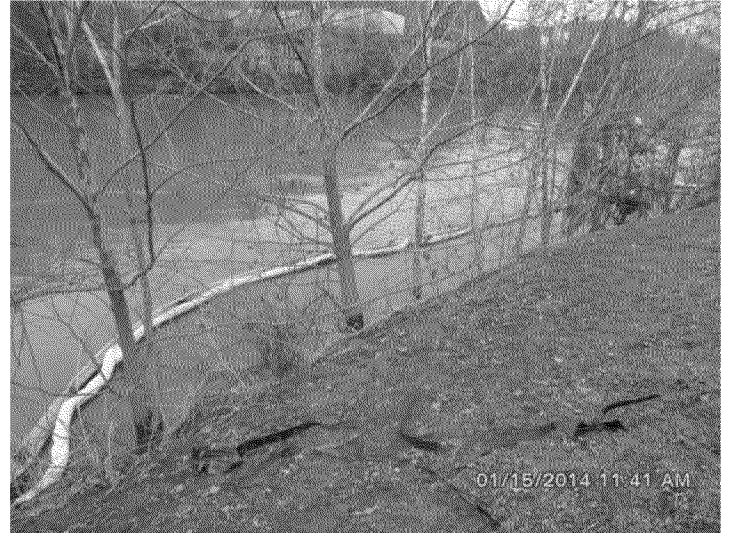
Photo No. SAM_1739; Taken on 01/15/14 at 11:42 hours by START MG . Absorbent boom placed around outfall from the oil/water separator

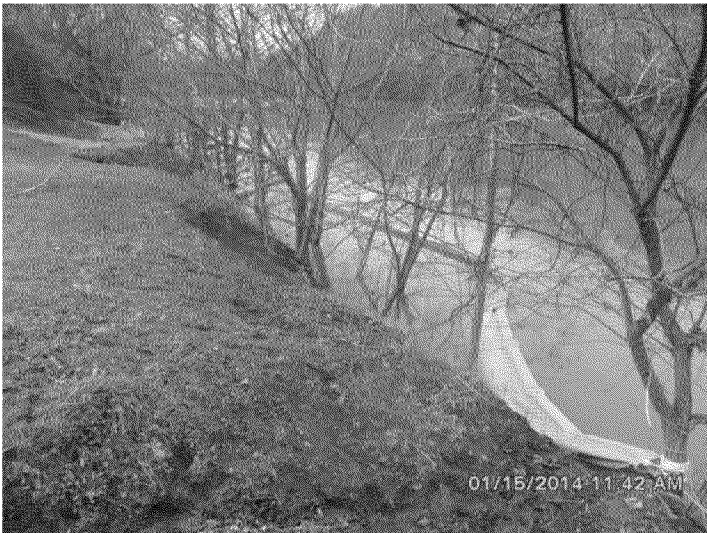
Photo No. SAM_1740; Taken on 01/15/14 at 11:43 hours by START MG. Booming on the south end of the site
